## **North Devon Council**

Report Date: 16<sup>th</sup> March 2022

Topic: Lynbridge car park - Lynton

Report by: SarahJane Mackenzie-Shapland; Head of Place, Property and Regeneration

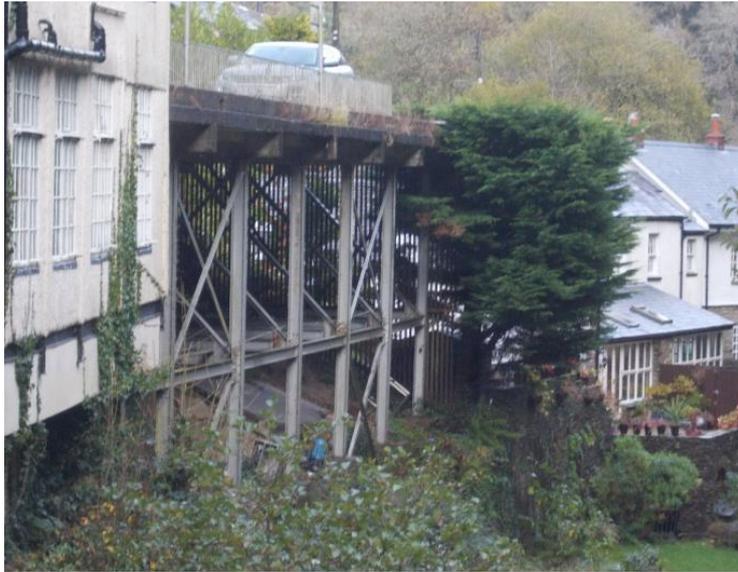
Photograph 1 shows a view of the elevated car park from footbridge

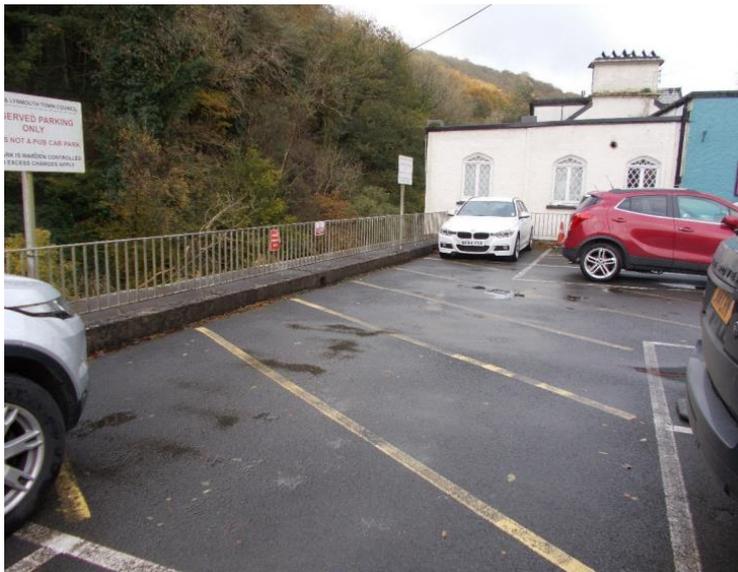
Photograph 2 shows the surface level of the Car park and identifies its use for reserved residential use only. The adjacent public house can be seen in the background and has separate car parking for patrons.

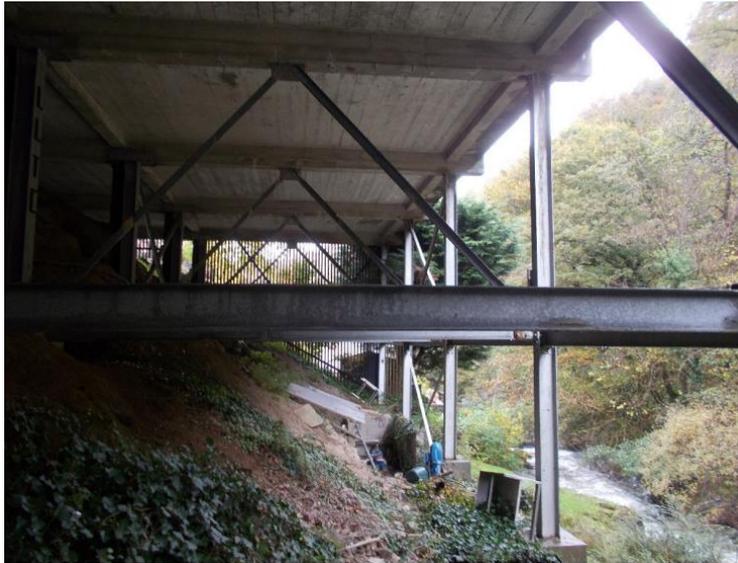
- 4.2. The car park consists of a tarmacadam surface laid over a reinforced concrete slab which spans left to right between the cross beams which extend from the roadside out to the rear steel columns. The cross beams are formed with steel beams (Universal Beams) encased in concrete. The perimeter of the car park has a 230 mm deep concrete upstand with steel handrails set at a height of 1.0 metres above the car park level. The handrails are formed with small squared steel section and show signs of light to medium corrosion both to the main members and their connections to the concrete beams.

Photograph 3 shows a typical cross section of supporting framework underneath the surface of the car park

- 3) The steelwork exhibiting signs of corrosion is to be repaired. This will be a site-based operation and will consist of chipping, scrapping by hand, sand blasting or mechanical power tools to remove the paint and rust back to sound base metal. The surface should be cleaned of any dirt and grease and then painted with a specialist anti corrosive paint system compatible with the exposed coastal environment. Any defective bolts are to be removed and replaced with bolts of similar grade and size. A method statement will be required for this element of works to prevent overloading of the reduced bolt connection in the temporary condition.
